Aircraft Accident Investigation Interim Report

Crash Into The Sea After An In-Flight Fire

Asiana Airlines

B747-400F/HL7604

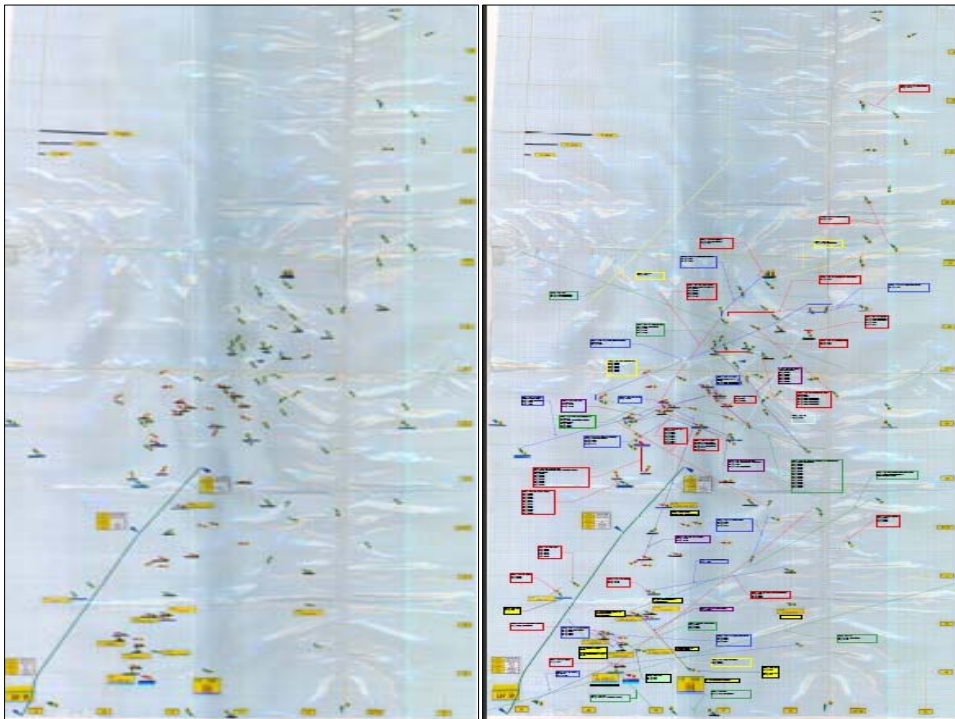
[Figure 16] Wreckage Distribution Map

As shown in [Figure 16], the wreckage was distributed in the area 3 km in width by 4 km in length in southwest-northeast direction.

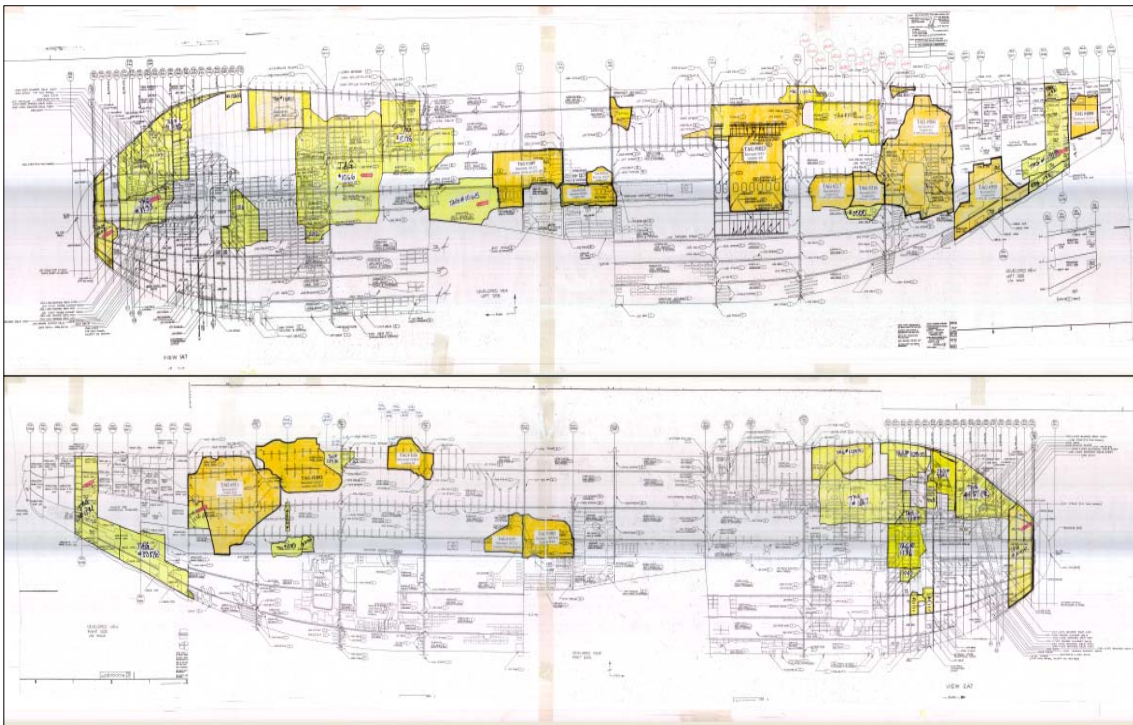
[Figure 17] Wreckage Marked on the Fuselage Diagram

The wreckage identified by the fuselage/structure group was marked on the fuselage diagram as shown in [Figure 17], and the wreckage recovered until October 30, 2011 was tagged²⁶).

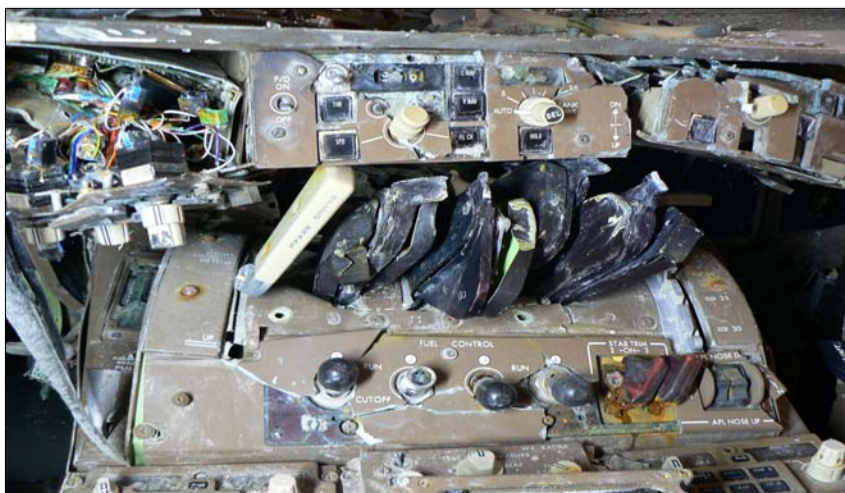
[Figure 18] Forward of the Cockpit (Throttle Quadrant and Mode Control Panel)

As shown in [Figure 18], the positions of switches and the condition of annunciator lights, circuit breakers, and various parts were examined.

Some of cockpit instruments were removed and under magnification, filaments of light bulbs were examined in order to identify whether annunciator lights had been hot at the time of impact.

The overall cockpit section was extensively pressure formed and was crushed flat.

Fuel cutoff switches #3 and #4 were found with the toggle in the OFF position, but under magnification, it was confirmed that they were OFF due to impact forces.

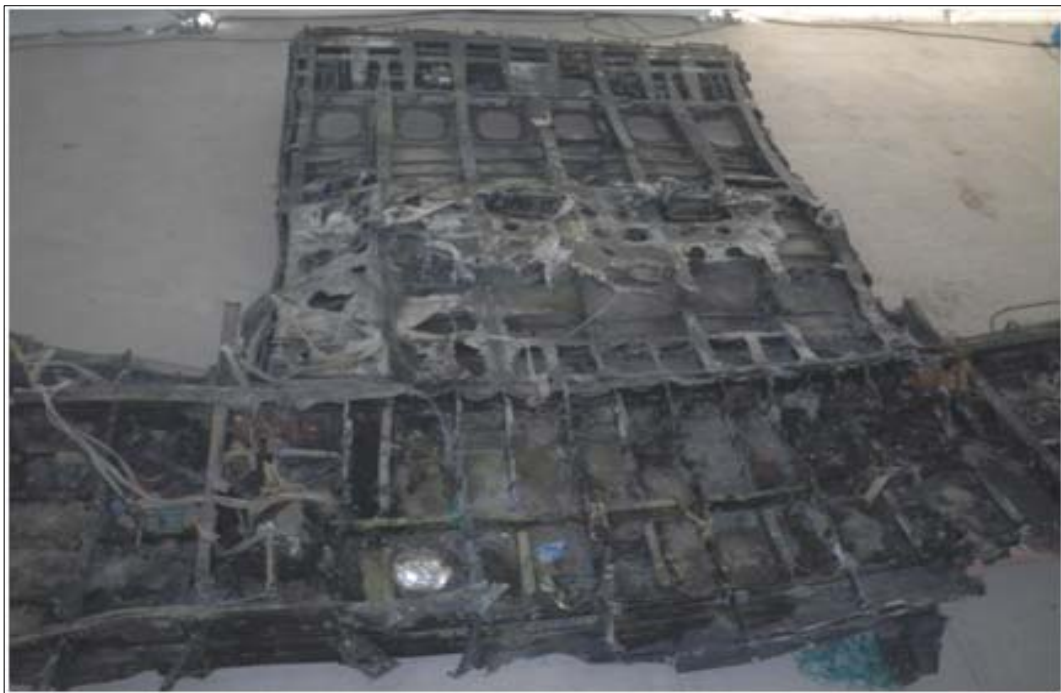
[Figure 27] Aft Main Deck Cargo Door

The wreckage from this area have the most fire damage of all the wreckage collected to date. Detailed thermal damage maps were generated for these portions of the aircraft. These portions included tag numbers 1089, 1112, 511, 1092, 1123, 1134, 221, 1108, 500, 216, 217, 2000, and 1023. They were mostly between the aft main deck cargo door and the L5 door as shown in [Figure 28]. This area can be characterized overall as having been exposed to the highest temperatures as evidenced by severe thermal damage on the interior structure and discoloration of the paint on the exterior of the aircraft's skin.

The aft main deck cargo door sustaining fire damage is shown in [Figure 27], and the thermal damage map for the wreckage with severe fire damage is shown in [Figure 28].

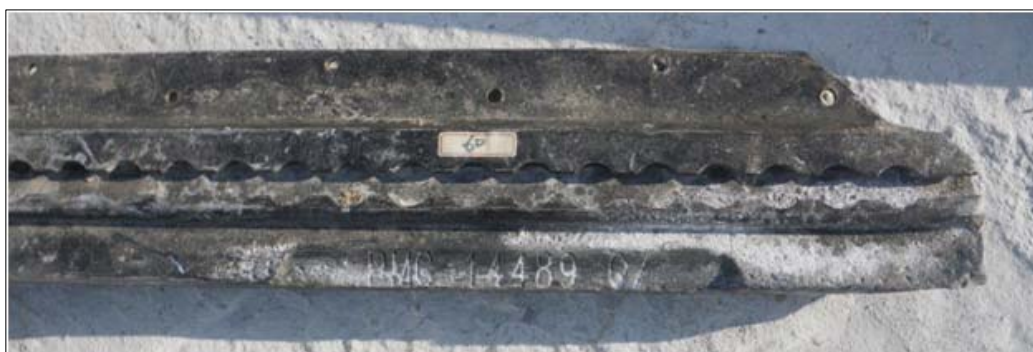
[Figure 33] Cargo Pallet Edge Rail

An example of a cargo pallet edge rail with fire damage is shown in [Figure 33].

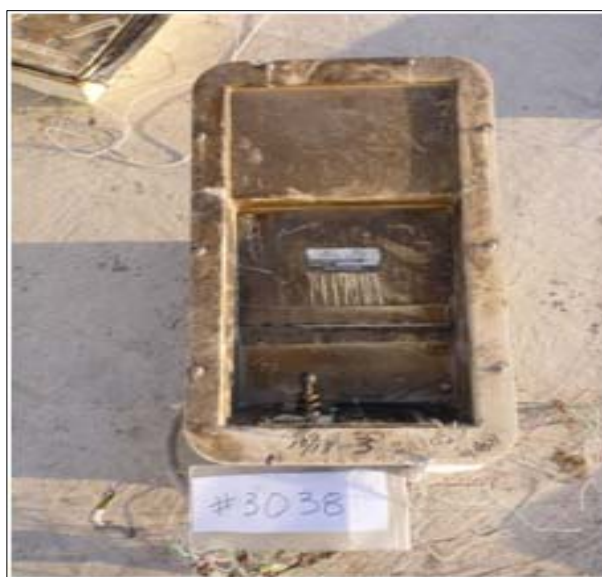
[Figure 34] Cargo Loading Control Panel

In the main cargo deck, there are multiple control panels for managing the loading of cargo pallets and containers and manipulating their positions. These control panels were found to have varying degrees of fire damage. An example of the cargo loading control panel is shown in [Figure 34].

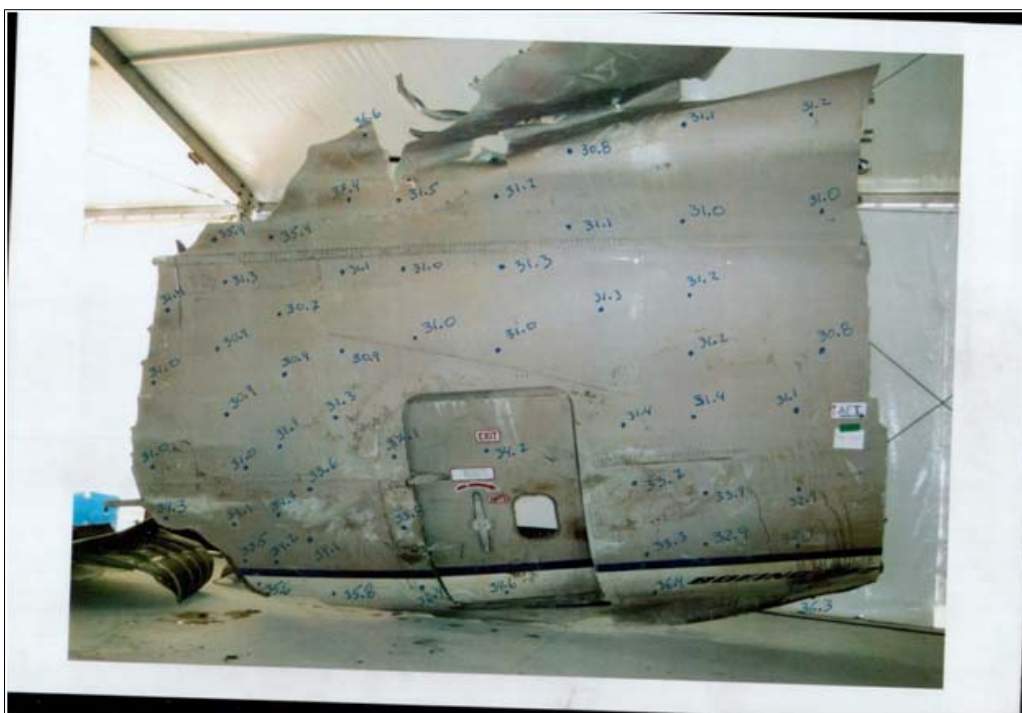
[Figure 38] Conductivity Measurement Points and Values

On a few of the large portions of the wreckage (#500, #1089, #511 and portions of the aft pressure bulkhead), measurements of the electrical conductivity were taken in an effort to see if that information would provide any additional insight beyond what can be accomplished by a traditional visual examination. An example of the conductivity measurements is shown in [Figure 38].

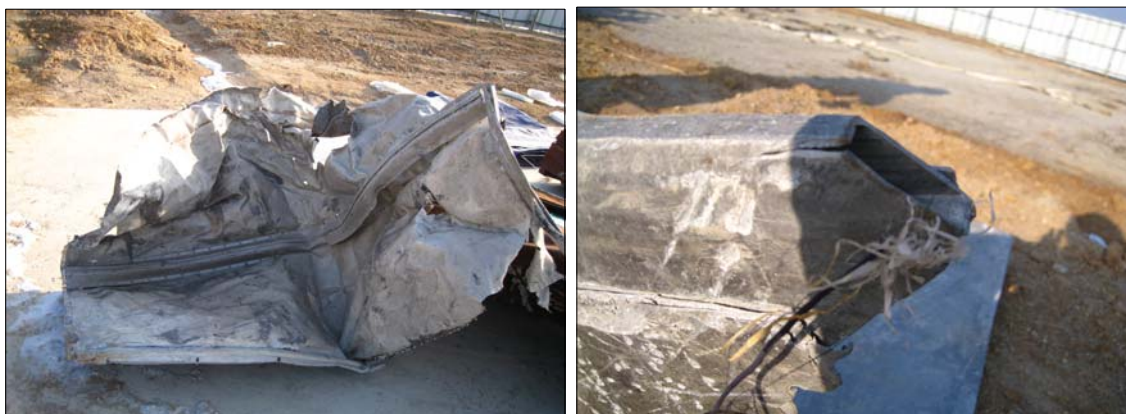
[Figure 51] Inside and Outside of the ULD Container at Position LL

The ULD container at position LL of the main cargo deck was recovered. No traces of fire damage was found on the inside of the wreckage as shown in [Figure 51], but the outside of the container was heavily covered in soot.

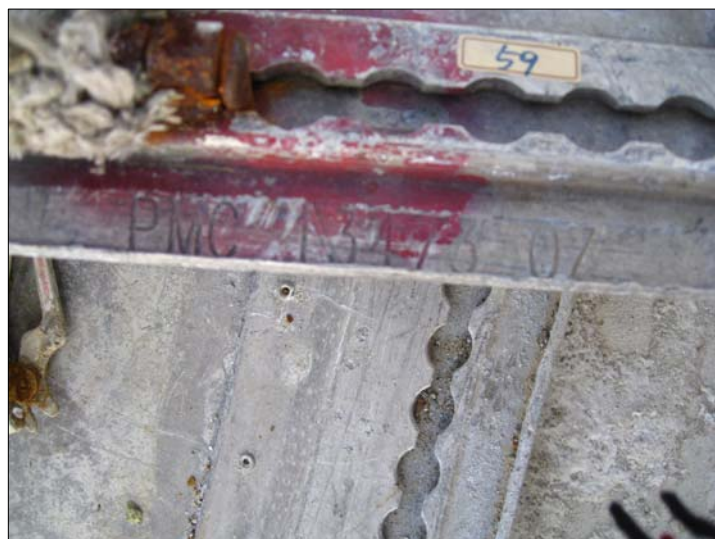
[Figure 52] Rail Sample Marked with Serial Number

Edge rails of cargo pallets were found separated from the pallets as shown in [Table 26], and the serial number of a certain rail could be confirmed as shown in [Figure 52].
